# Determination of the bed level at the Gameraen side channel: measurements with a Fishfinder.

A report by HKV, commissioned by Rijkswaterstaat as part of the Interreg North Sea Region Building with Nature project. Translated from Dutch by Ralph Schielen (Rijkswaterstaat).

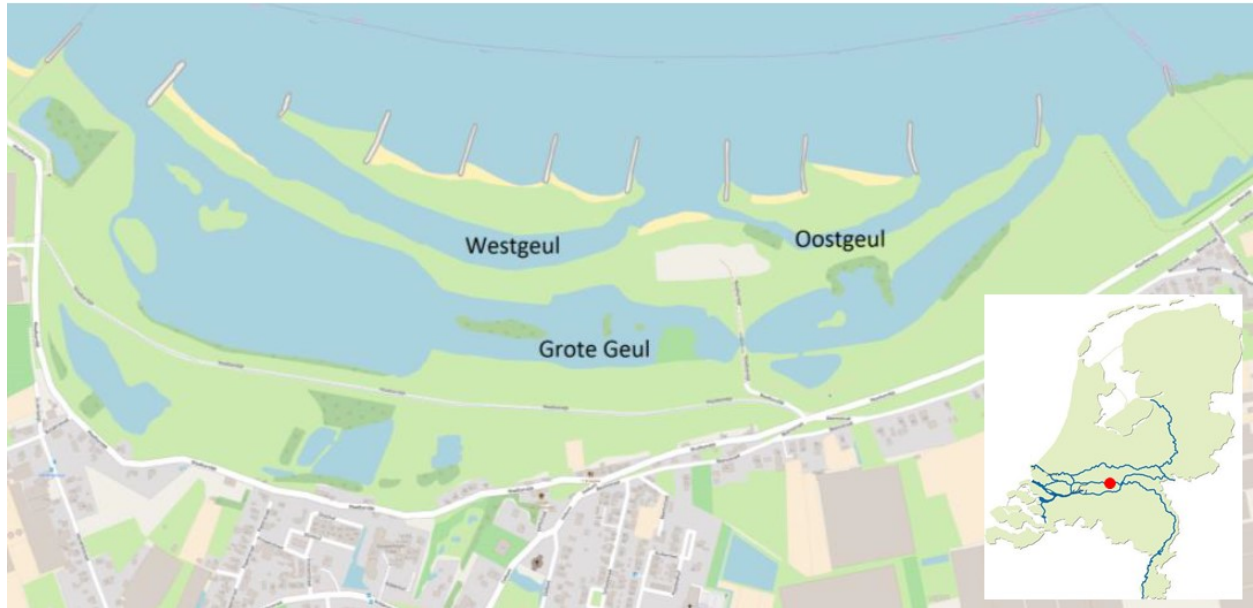
Figure 1: Side channels at Gameren: West channel ('Westgeul'), East channel ('Oostgeul') and Large channel ('Grote Geul'). The red dot indicates the location of Gameren in the Netherlands.

In figure 1, the situation of the Gameraen side channel system is visualized. The pilot study concentrated on the upstream part of the 'Grote geul' (Large channel). 'Oostgeul' and 'Westgeul' mean East channel and West channel, respectively.

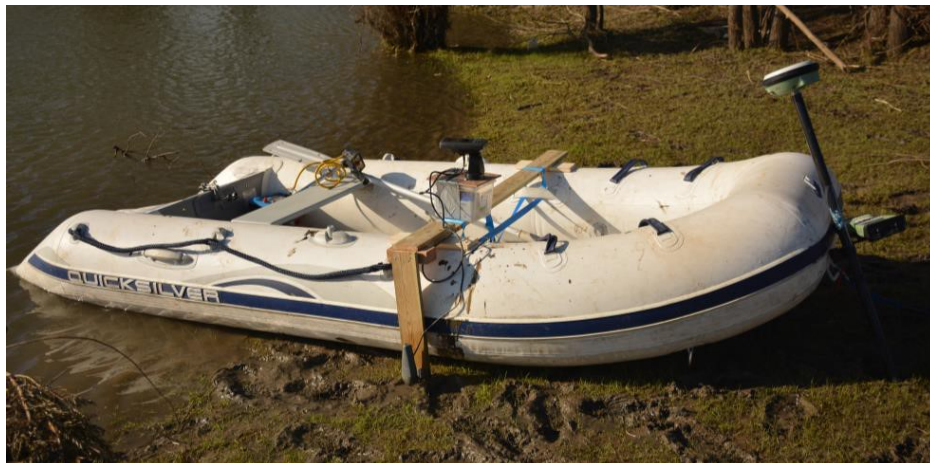
Figure 2: equipment needed for the measurements. The Fishfinder is visible mounted on the vertical shelf.

Measurements have been carried out on February 14, 2018, two weeks after the passage of a moderate high discharge wave. At the time of the measurements, the floodplains were not inundated. The measurements have been carried out with a Fishfinder Garmin Echomap 42 mounted on a zodiac rubberboat with electrical engine. A dGPS was used to measure the water level.

The Garmin Echomap 42 is a single beam Fishfinder with a maximal frequency of 200 kHz at a measuring angle of 10 degrees. It comes with a built in 5 Hz GPS. In figure 1, a photo of the vessel and the experimental set up is shown. In figure 2, an example of the display of the Fishfinder when measuring is given.

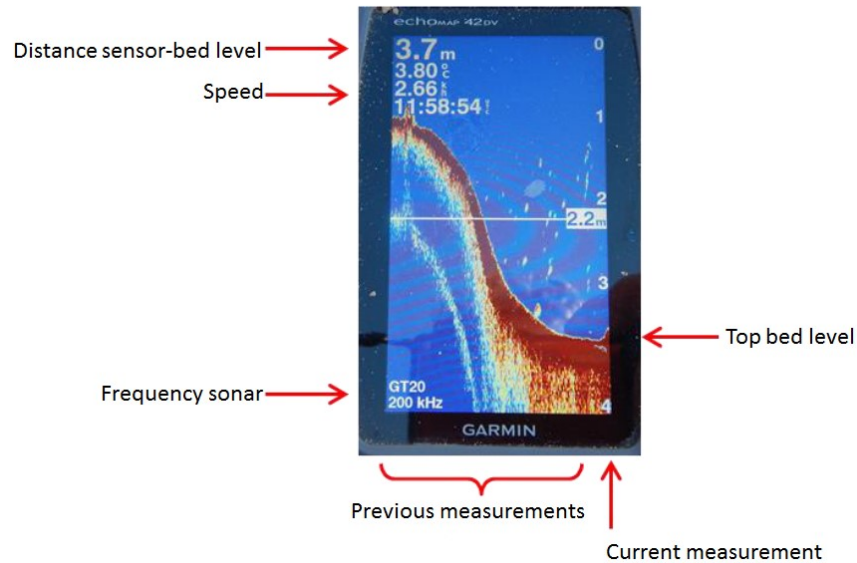
Figure 3: Display of the Garmin Fishfinder

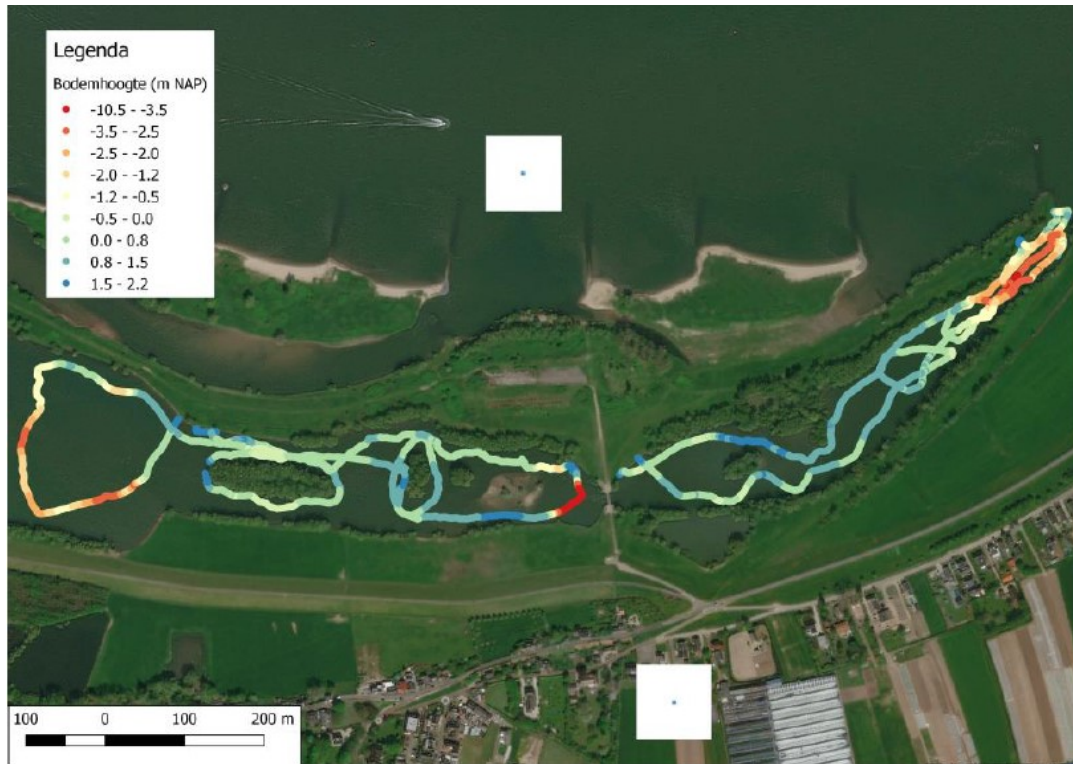
Figure 4: Tracks and measured depth, using the vessel and the fishfinder.

The measurements of the Fishfinder have been transformed into a covering map of the large channel, using the interpolation tool box in GIS. Only in the most upstream part of the large channel, the density of the measurements was sufficient to perform this interpolation. In figures 4 and 5, the Fishfinder tracks and the interpolation are shown. In figure both figures, the erosion in the upstream part, and the scour hole just downstream the bridge is clearly visible in figure 5.

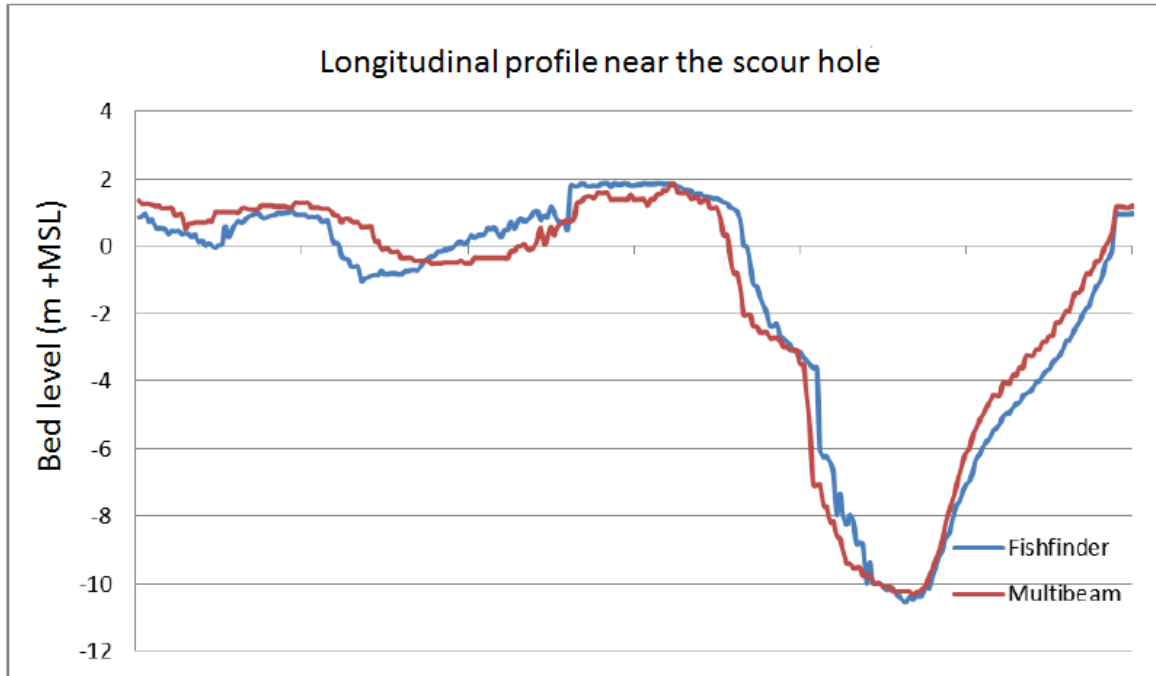
Figure 6: Comparison between the measurements with the Fishfinder and the multibeam measurements. The location is near the bridge, visible in the center of Figure 4. The scour hole is clearly visible in the figure (right hand side).

By coincident, Rijkswaterstaat performed multibeam measurements in a part of the large channel just two weeks before the measurements with the Fishfinder. This gave the opportunity to compare parts of the multibeam measurements with the Fishfinder measurements. The findings were the following (see also Figure 6):

- The Fishfinder data is in average 11 cm lower (standard deviation 28cm) in bed level than the multibeam data
- Deviations are mainly found in steel slopes
- The general pattern of steep and weak slopes is retrieved in the Fishfinder data (although sometimes a little bit translated in space)

The explanation for these findings are:

- Morphological changes between the two measurements
- Presence of silt
- Uncertainty in the position of the GPS of the Fishfinder
- Uncertainty in the exact position of the sensor of the Fishfinder
- Local water level in the Large Channel
- Uncertainty in the calibration measurements (using the gauging rod) of the Fishfinder
