GUIDELINES FOR DESIGNING SAND NOURISHMENT ON LOW TO VERY EXPOSED COASTS

Henrik Vinge-Karlsson, Danish coastal authority, Henrik.Vinge.Karlsson@kyst.dk
Per Sørensen, Danish coastal authority, PSo@kyst.dk

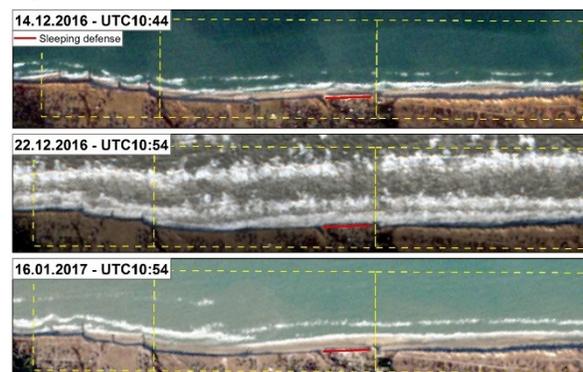
Satellite images from Sentinel 2 and regular drone footage have been used for determination of variability in the active coastal zone at Nørlev. Fig 2 shows Sentinel2 images with a resolution of 10x10m. The variability of the bar system has been identified, and a depression in the outer bar is identified outside of a location of significant dune erosion (red line).

Figure 2 - Satellite images of breaker bar system
