**FILTER SYSTEMS FOR A  
SUSTAINABLE AGRICULTURE**

# FIELD CASE DESCRIPTION

Phosphorus filters  
for drain water from horticulture

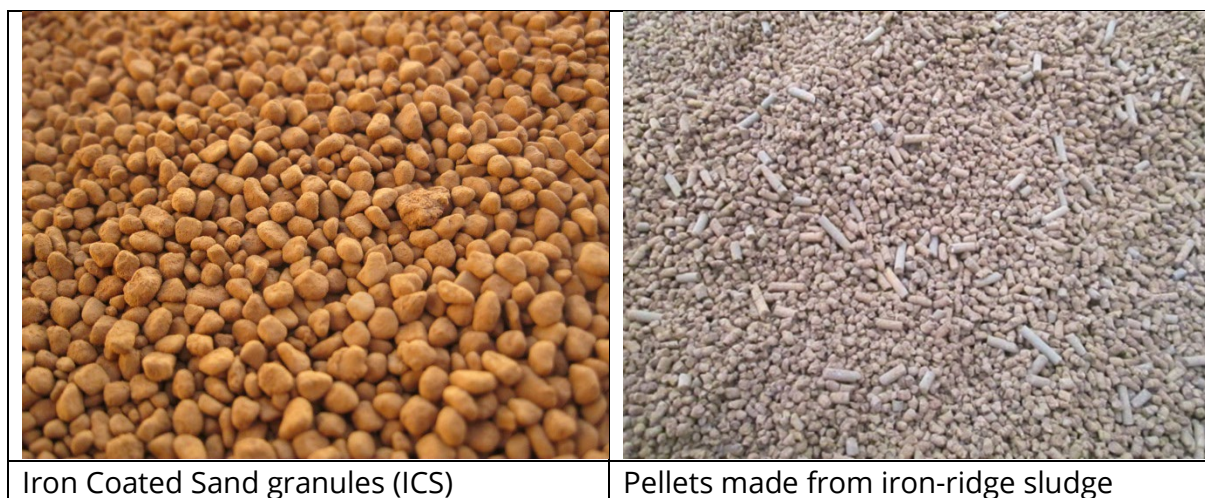
*Photo 1 Iron Coated Sand granules (ICS) (left) and pellets made from iron-ridge sludge (right) at the start of the trial*

Waste products of drinking water companies can be used as filter material for P removal. During the production of drinking water, drinking water companies apply biological and adsorptive deferrization because groundwater often contains high iron concentrations (> 15 mg/l). In addition to biologically formed iron sludge, there is also iron adsorption on sand grains. In this fast sand filtration process, ICS (= Iron Coated Sand) is formed by the adsorption of iron on the sand cores. Due to the deposition of iron on the grain surface, the iron grain grows steadily and part of the grain must be removed from the sand bed periodically. It is this waste material (ICS) that can be used for another adsorption processes including the removal of phosphate (Photo 1).

In case the iron removal from groundwater results in solid iron sludge, this sludge can be pelletized and the phosphate removal takes place via the same process (Photo 1).

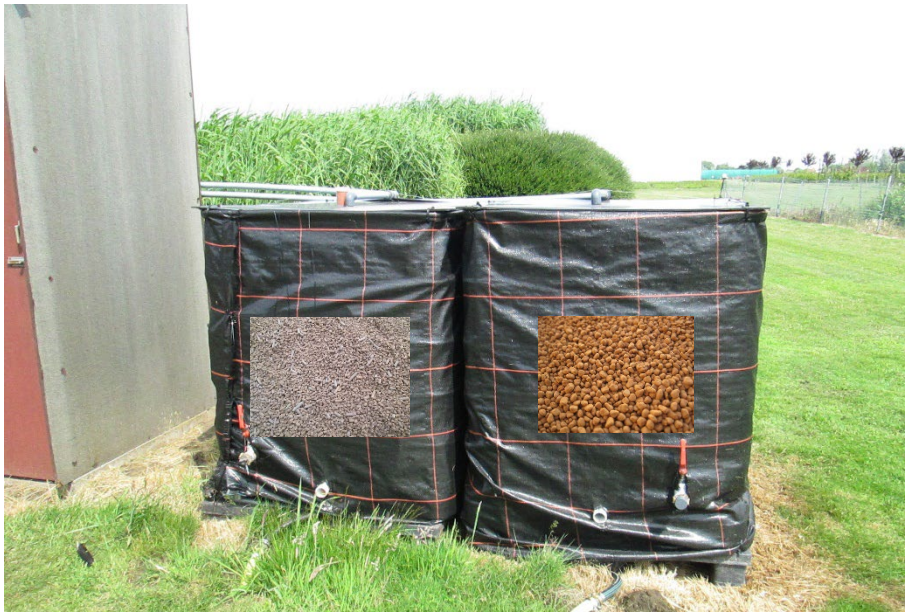
*Photo 2 Two P filters at PCS (in parallel)*

At location 1, 2 types of filters to remove P were compared: 2 IBC tanks of 1 m<sup>3</sup> were filled for 80% with iron-ridge sludge pellets or ICS grains (Photo 2).

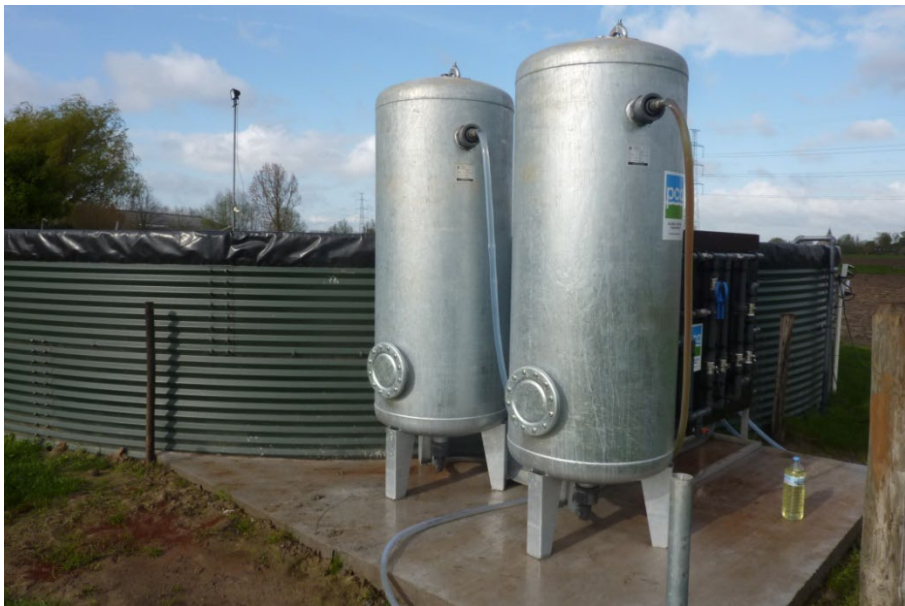
*Photo 3 Two P filters at Floristry Meuninck (in series)*

At location 2, 2 filters filled with ICS grains were installed in series and the tanks were filled for 80% with ICS grains. Wastewater passed through both filters (Photo 3).

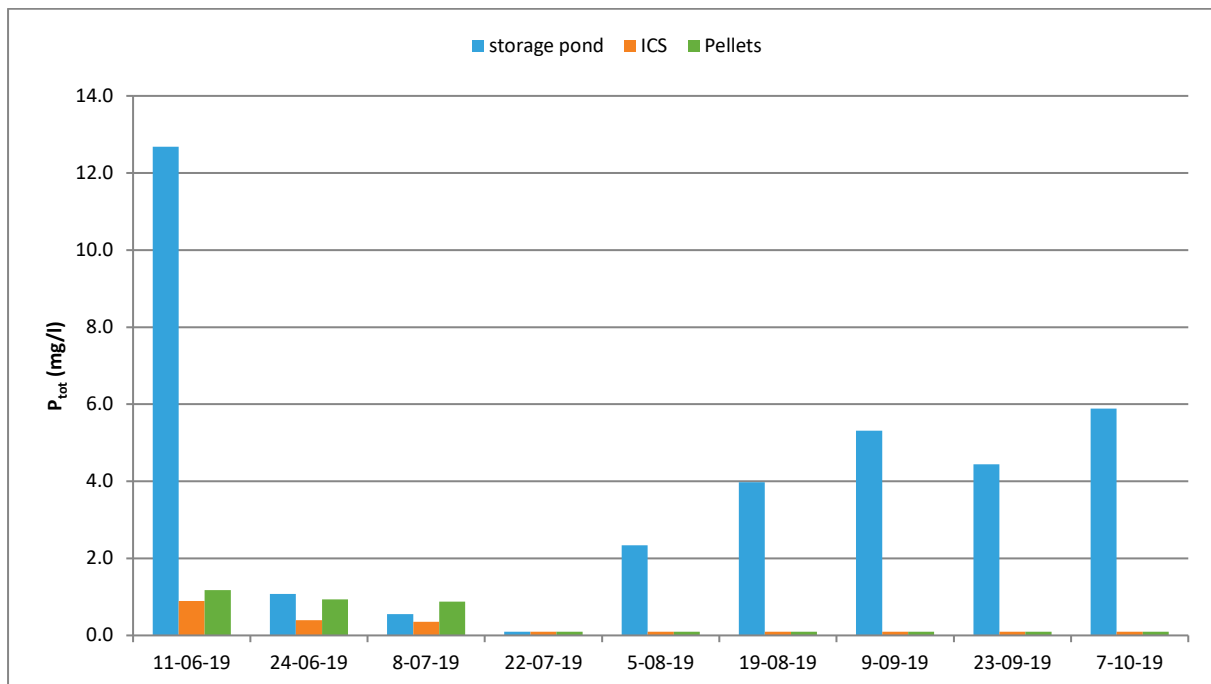
Figure 3 Results for P filters at PCS during summer 2019

Because of some months of inactivity in winter, saturation was avoided and in 2019, the efficacy of the P filters was excellent again without replacing ICS granules (Figure 3). In 2019, all P in the water of the storage pond was adsorbed onto the filter materials. Till the end of September, 1,3 m<sup>3</sup> per day was pumped through both filters. Also the effluent of the MBBR passed through both P filters which resulted in higher filtered volumes. At the end of September, the pump capacity was increased: 18 times a day, 120 liter water was pumped through each P filter which means 2,2 m<sup>3</sup>/day through each filter.

In September 2017, September 2018 and November 2019, the level of adsorbed P on the grains and on pellets were determined by the KULeuven (Table 1). There was still more than sufficient capacity for the granules and pellets to adsorb P. Lab grains were already saturated after 4,40 mg P/g DW, but we could determine that in practice, levels up to 16 mg P/g DW are possible. This is due to the fact that P can migrate deeper into the grains, especially in times of rest (discontinuous flow). In this way, new adsorption places are available at the outside layer. This explains why it was not necessary in 2019 to replace the material. This was also confirmed by Figure 3, where we could see that in 2019, P was removed from drain water for both filter materials.

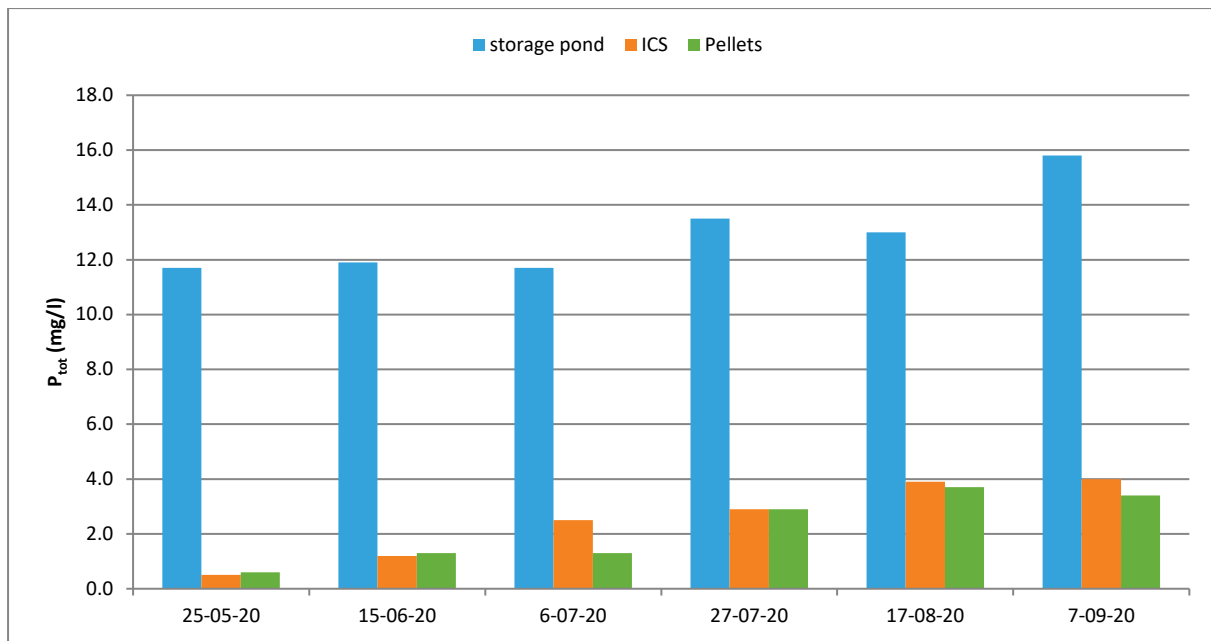
Figure 4 Results for P filters at PCS during summer 2020

In 2020, the amounts of P in the storage pond were higher than 12 mg/l. The filters worked well but not perfect (Figure 4). Each day, 0,75 m<sup>3</sup> water passed through each filter. There was a serious reduction in P, but concentrations remained from July on between 2 and 4 mg/l P. Filters may be saturated, therefore, samples were taken to be analyzed by KULeuven.

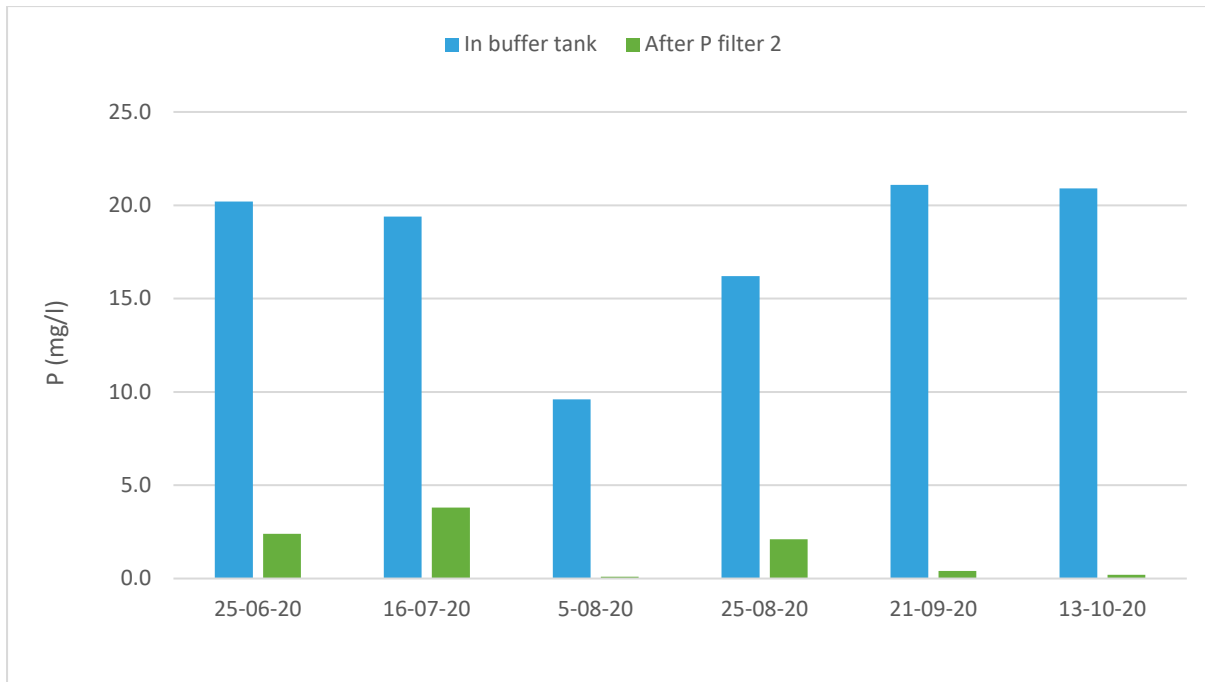
Figure 9 Results of P removal for P filters at Floristry Meuninck in 2020

Also in 2020, P filters worked very well (Figure 9). Almost all P was removed from the drain water.
