Filter description

Results (through the different seasons)

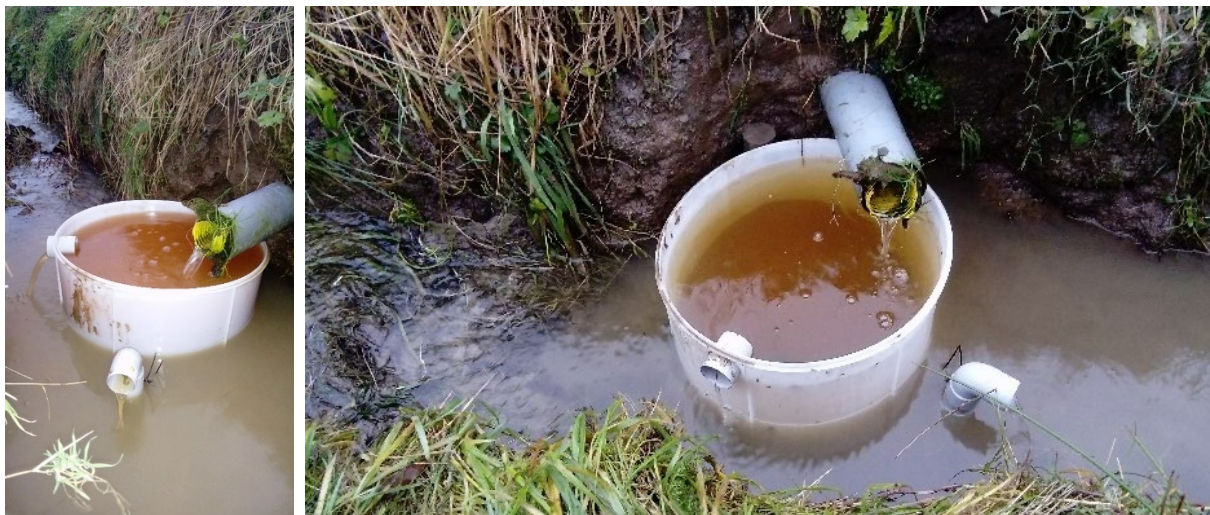
Figure 2. Schematic overview of the installation of P filters in the field

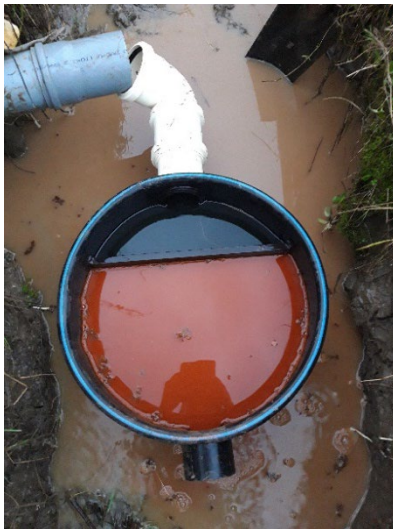
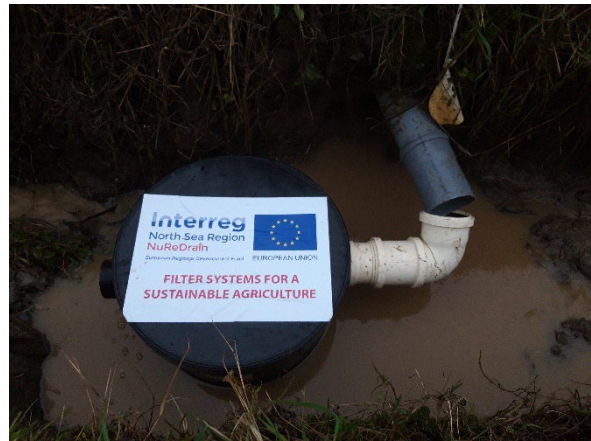
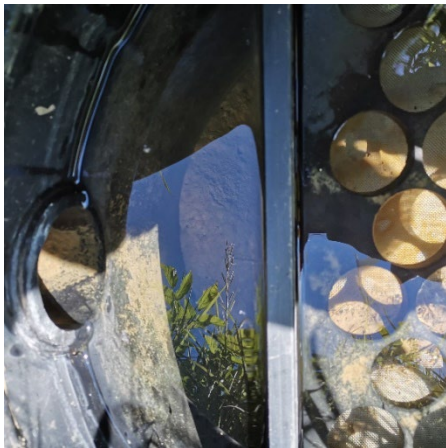
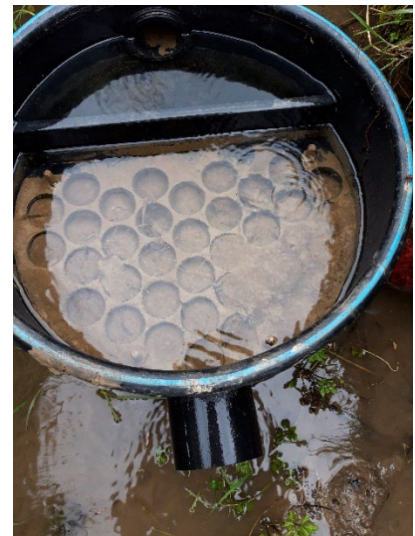
The new prototype filter (cylindric shape, Figure 4) was installed in December 2019 with sieved filter materials (ICS>2mm). A layer of 24 cm with approximately 35 l of ICS was filled in the filters. The prototype from season 2019-2020 was kept until March 2022 to check the long-term performance of the filter. From January 2021, overflow was observed and the filter was gradually clogged by sediment as shown in Figure 4, not only at the bottom but also at the top of the filter.

Figure 4. Prototype installed in the season of 2019-2020, 2020-2021, and 2021-2022.
