Upscaled P filter for drainage water

Problem description

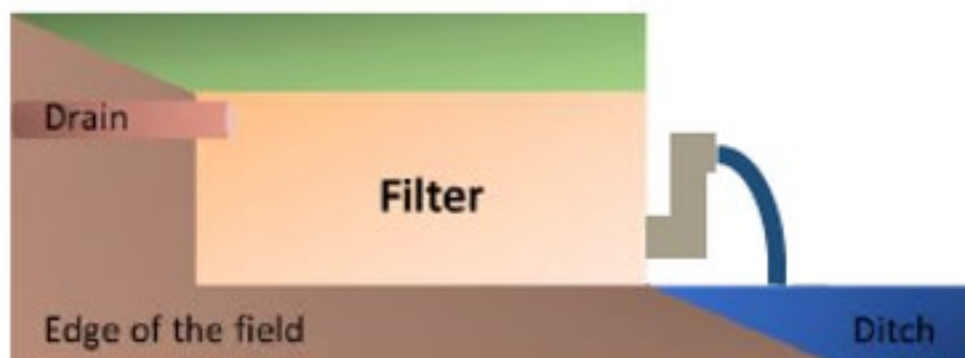
Figure 2. Schematic overview of the installation of P filters at individual drainage tubes in the field

P concentrations in the drainage water are too high (on average 0.47 mg TP/l and 0.37 mg DRP/l) to meet the EU standard in the receiving surface water. The basic concept to reduce these P losses is installing a filter box containing a P sorbing material (PSM) at the end of the drainage tubes. This forces the water through the filter material and allows the removal of P from it before entering the ditch (Figure 2). We have developed filter boxes that have been installed at the end of single drainage tubes. This design works well for the typical discharge of individual drainage tubes, but needed to be upscaled to also efficiently treat larger volumes of water as in the case for collector drains.

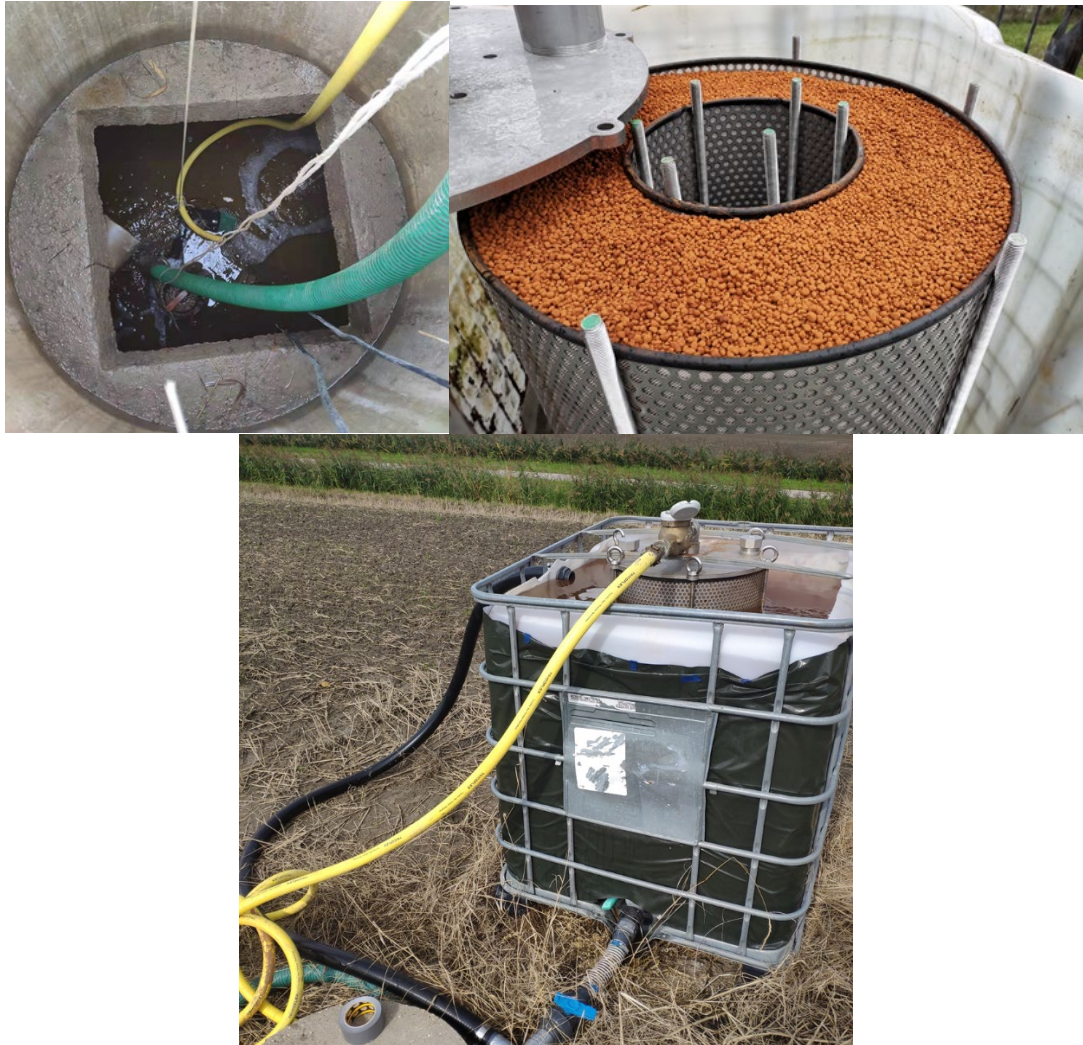
Figure 3. The upscaled P filter in Middelkerke

One upscaled P filter, a concentric cylindrical filter element within a cubic container, was installed on 1st March 2022 (Figure 3). The concentric cylindrical filter element was constructed by two cylindrically shaped wire meshes, with 140 L ICS filled in between the cylinders. Water from the collector drain was pumped to the central cylindrical cavity of the filter element, and then forced to pass the concentric cylindrical filter element with a thickness of 14 cm, from the center towards the outside. The P in the water passing through the ICS is (partially) sorbed, and then discharged from the cubic container into the ditch. In the first year, there was only one outlet at the bottom of the cubic container for water discharge. This configuration led to partial use of the filter, as the inflow was lower than the capacity of the outlet, resulting in a water level that was not consistently high and, consequently, only partial use of the ICS for phosphorus absorption. To address this issue, the flow at the bottom outlet was reduced, and an additional outlet was installed at the top of the cubic container in the second year. This modification ensured a consistently higher water level in the cubic container, thereby facilitating the full use of the ICS.

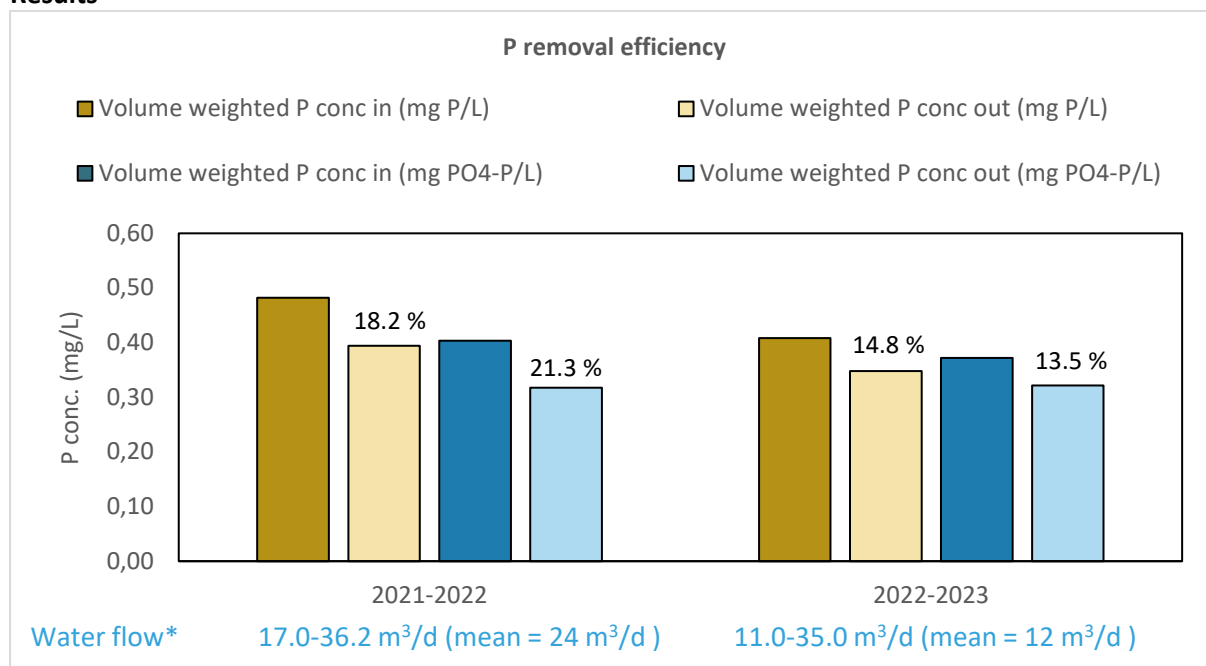
Figure 5. P removal efficiency of upscaled filter during the season 2021-2022 and 2022-2023.

At the site of Middelkerke, 18.2% of total phosphorus (TP) and 21.3% of dissolved reactive phosphorus (DRP) was removed by the filter box during the period of 01/03/2022 - 26/04/2022 with a water flow of 17-36 m³/d. During the second drainage season, the P removal efficiency was not improved although the water flow was reduced to 12 m³/d averagely.

During the first season, the upscaled P filter showed the potential of treating a large water flow up to 36 m³ per day. However, P removal efficiency was not satisfactory (around 20%) and considerably below the performance of the small P filters for individual drainage tubes. We assume that the high water flow and thus the relatively short contact time is a possible reason for the reduced P removal efficiency. Adjustments of this filter system have been made to increase the contact time (e.g. reducing flow) during the second drainage season, however, the P removal efficiency was not improved and much lower than the other upscaled P filter installed at Roeselare (Godelievegronden INAGRO). We suspect that the water composition at this site might hinder the P absorption of phosphate by ICS, which need to be confirmed with further research.
