P filterbox for drainage water

Location

City: Staden

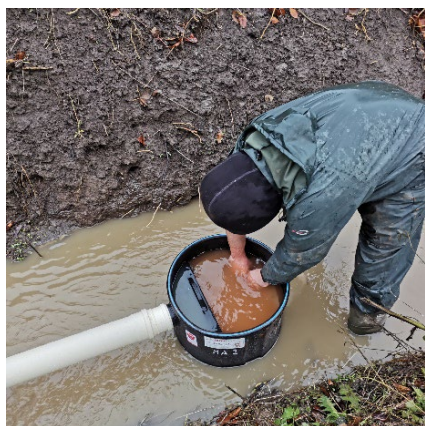
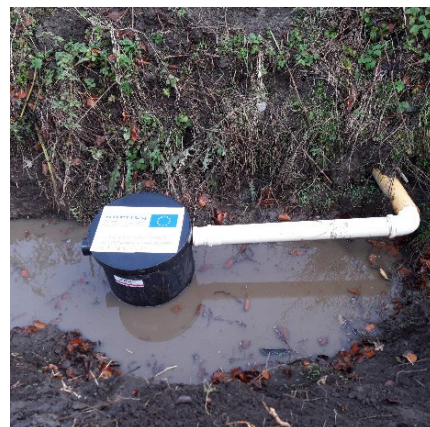
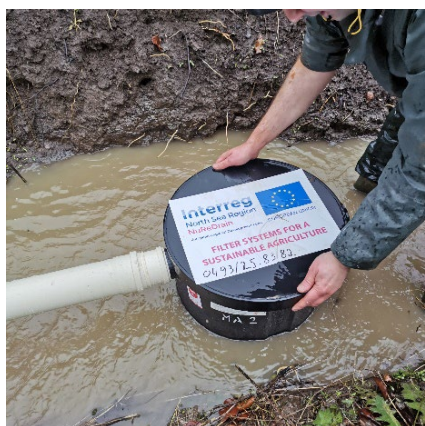
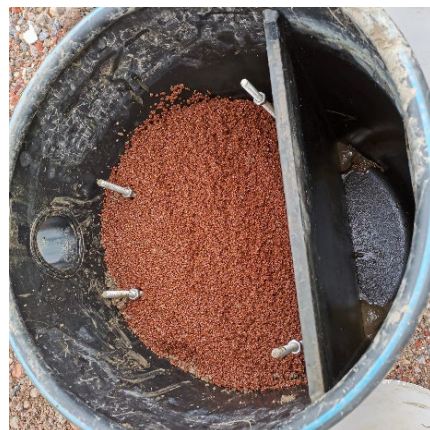
Figure 4. Prototype installed in the season of 2019-2020

The new prototype filter (cylindric shape, Figure 4) was installed in December 2019 with sieved filter materials (ICS>2mm). A layer of 24 cm being approximately 35 l of ICS was filled in the filters.

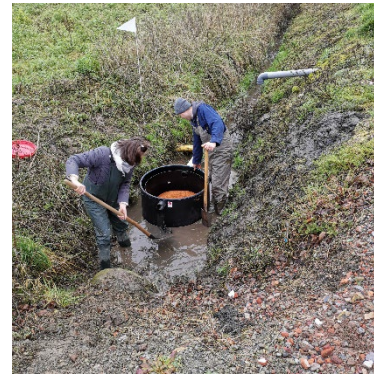
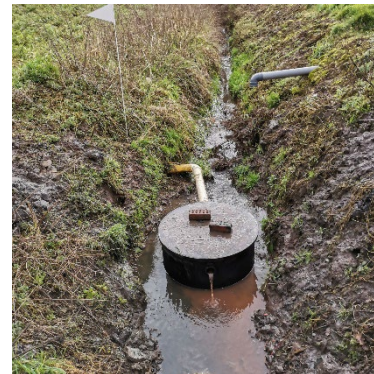
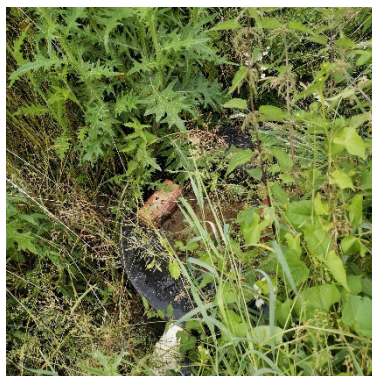
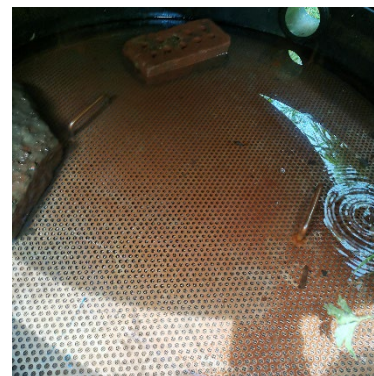
Figure 5. Larger prototype filter installed in February 2021

The prototype from season 2019-2020 was kept until January 2021. Then a bigger filter was installed on 2 February 2021 and filled with a layer of 24 cm, approximately 120 l, of ICS >2mm (Figure 5). The water in Staden was drained from a larger field (1-2 ha) which was beyond the processing capability of the small filter. Therefore, a bigger filter was designed and installed to check if P removal efficiency could be improved.

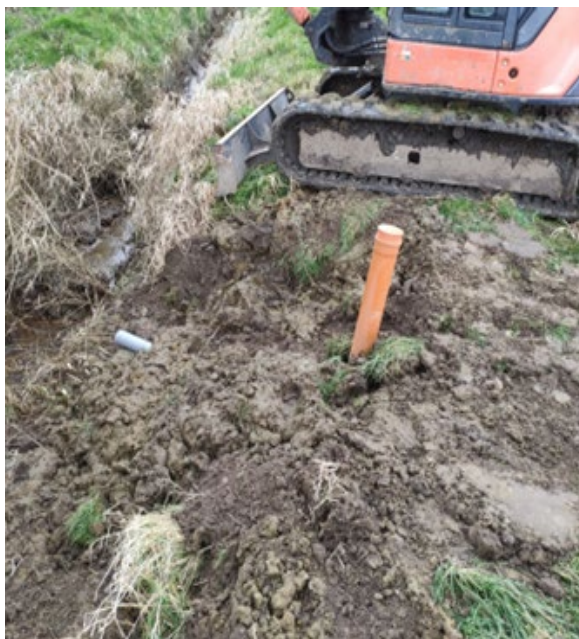
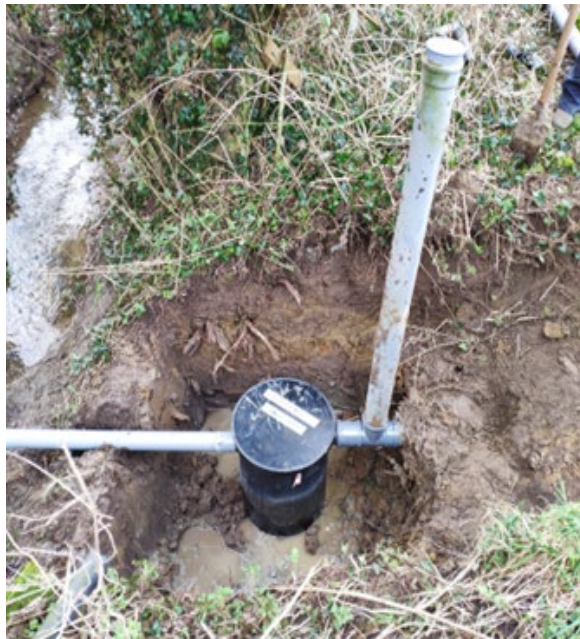
Figure 6. Dig-in filters installed in Jan 2021

Two prototype filters were installed by burying the filter boxes at the edge of two different fields to avoid disturbing the waterway. These filters were tested for two drainage seasons (Fig 6). These filters contain a vertical tube for collecting water samples before passing through the filters. The installation is more complex than just placing the filter in the ditch and connecting to the drainage pipes, while it has been proven feasible with a small crane.

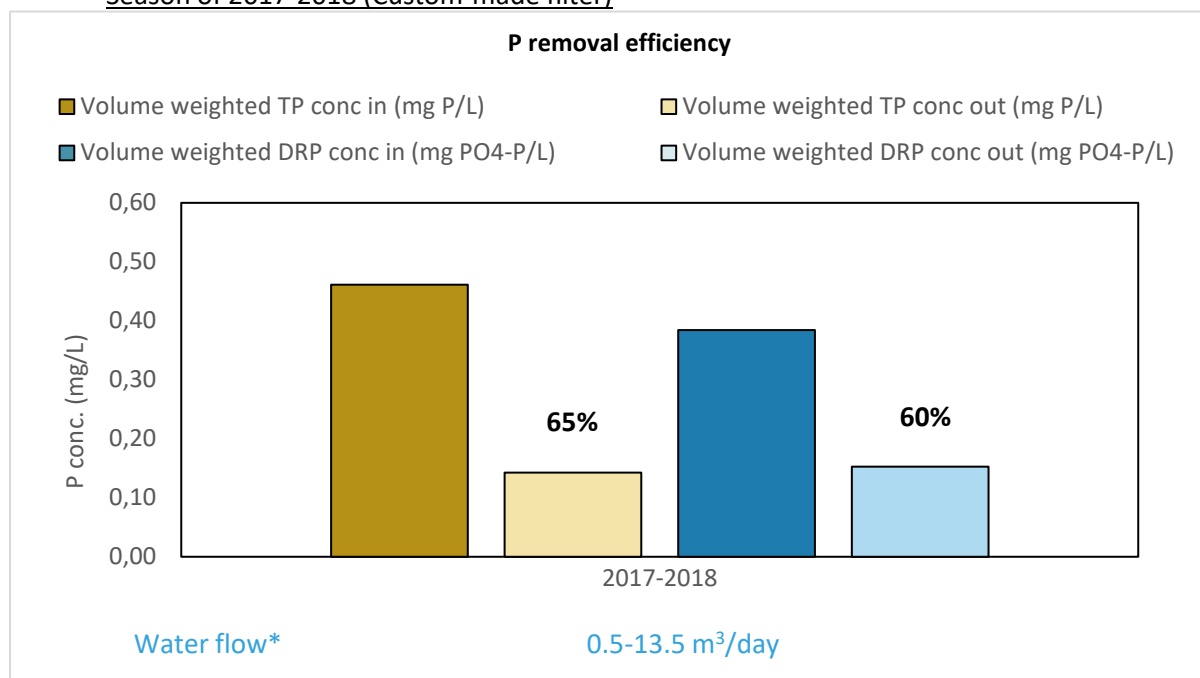
Figure 7. P removal efficiency of custom-made filter box during the season of 2017-2018.

*water flow was measured every week and this range represented the water flow on the measuring days.

In the site of Staden_Groot, 65% of total phosphorus (TP) and 60% of dissolved reactive phosphorus (DRP) was removed by the custom-made filter during the period of 9/1/2018 - 11/4/2018 with an average water flow of 5 m³/day. Frost problems occurred during the period of 21/2/2018 - 28/2/2018.

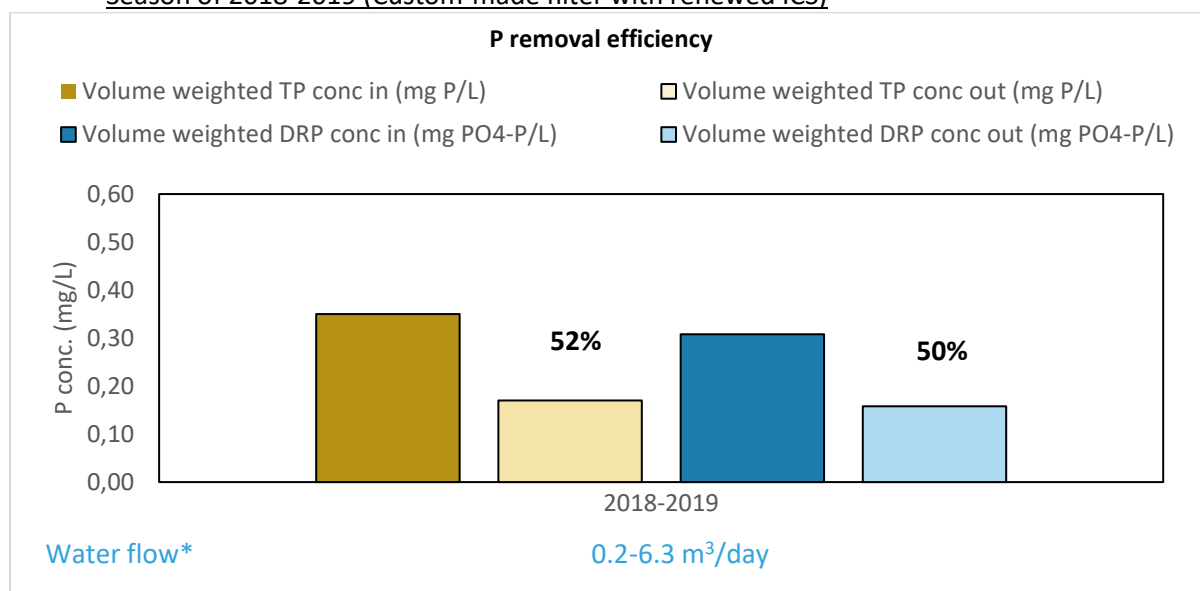
Figure 8. P removal efficiency of custom-made filter box during the season of 2018-2019.

*water flow was measured every week and this range represented the water flow on the measuring days.

At the site of Staden_Groot, 52% of TP and 50% of DRP was removed by the custom-made filter during the period of 20/12/2018 - 28/3/2019 with an average water flow of 2.3 m³/day. Overflow happened on the dates of 31/1, 8/2, 8/3, 15/3/2019 and a white foam was observed in the drainage tube on 8/2/2019.

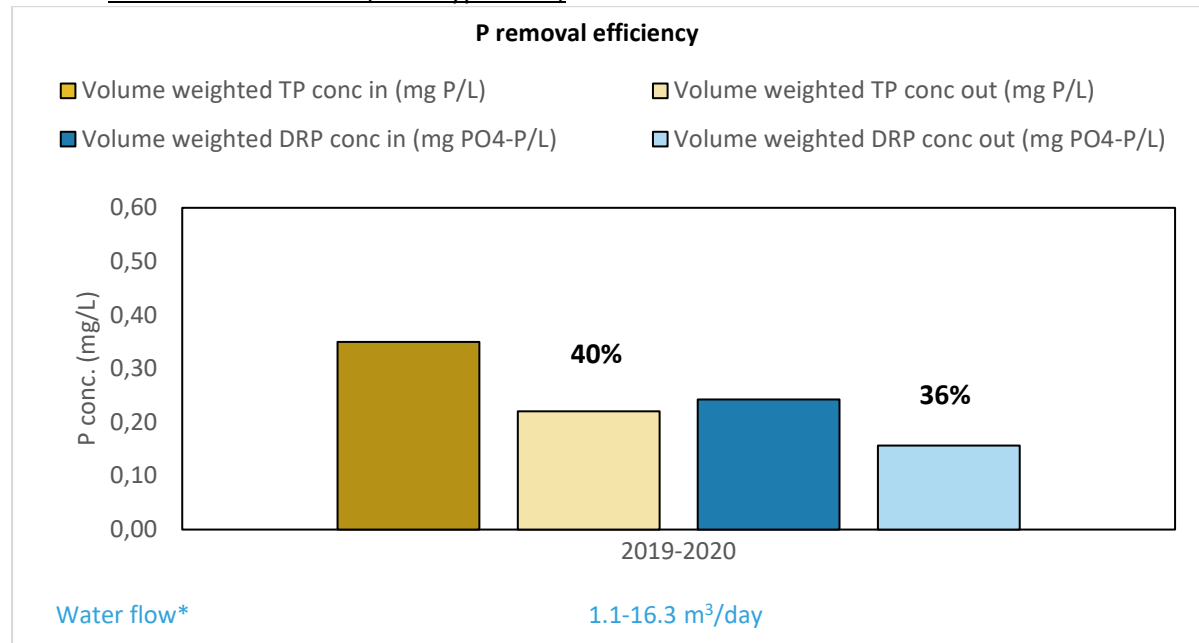
Figure 9. P removal efficiency of prototype filter during the season of 2019-2020.

*water flow was measured every week and this range represented the water flow on the measuring days.

At the site of Staden_Groot, 40% of TP and 36% of DRP was removed by prototype filter during the period of 9/1/2020 – 13/3/2020 with an average water flow of 6.36 m³/day. It was reported with overflow on the dates of 10/2, 14/2 and 3/3/2020.

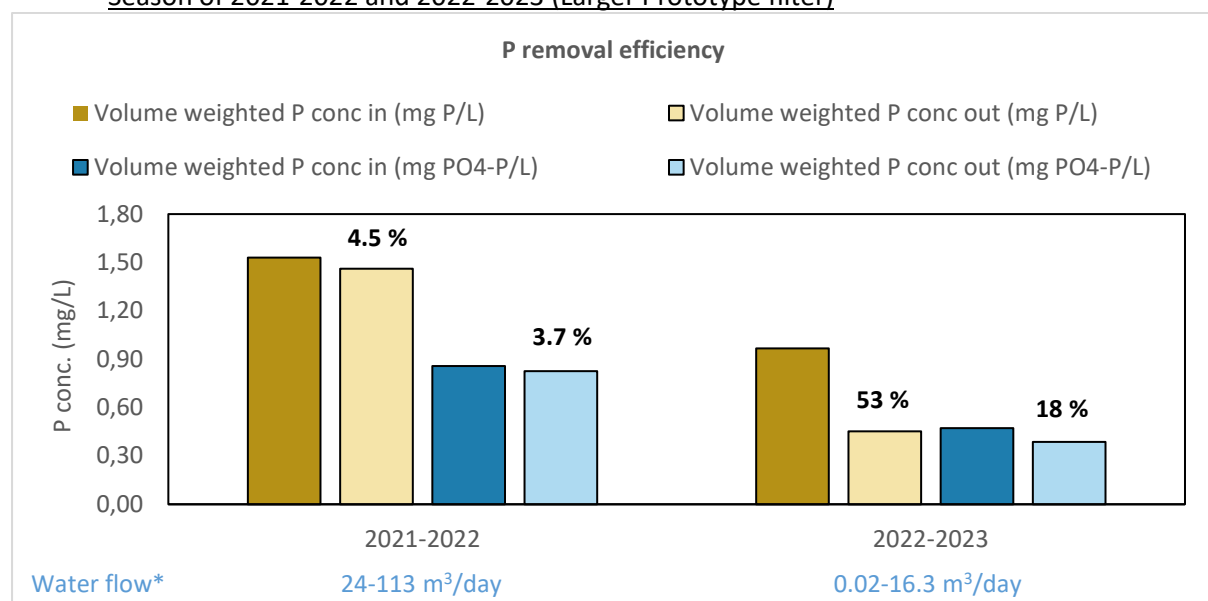
Figure 10. P removal efficiency of prototype filter during the season of 2019-2020.

*water flow was measured every week and this range represented the water flow on the measuring days.

At the site of Staden_Groot, the prototype during drainage season 2019-2020 showed low P removal efficiency (40-65% of TP and 36-60% of DRP) compared to site Zedelgem due to the large water flow. However, this larger prototype filter with 120L ICS did not show better performance with the high flow rate, which probably due to overflow. Still, with the flow below 4.8 m³/d, the filter showed better performance (55 % of TP and 53 % of DRP)

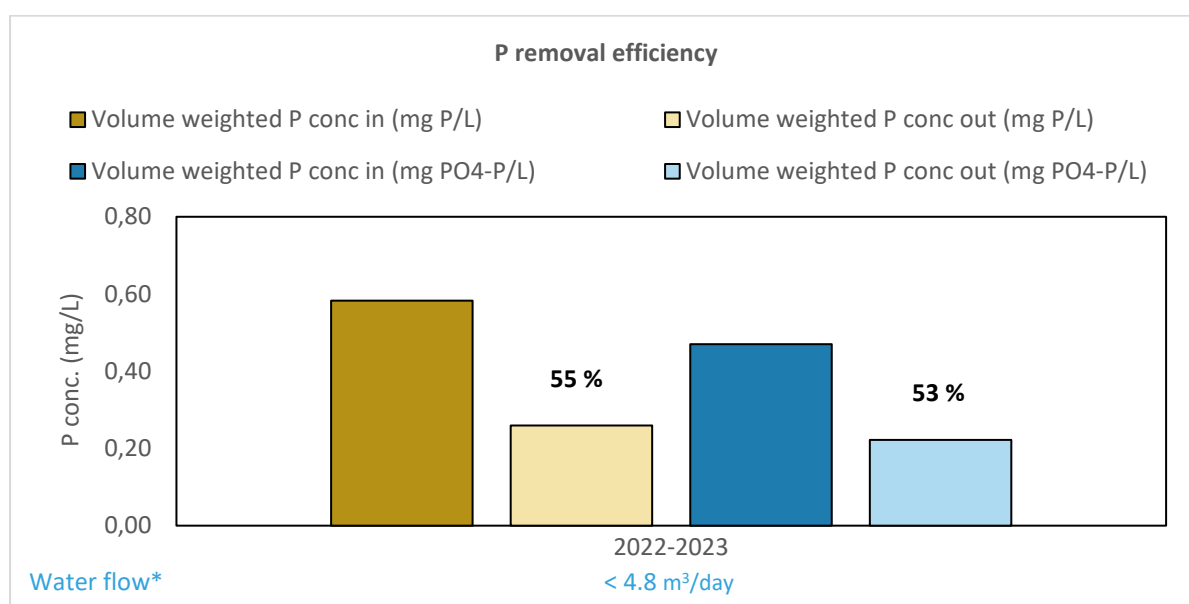
Figure 11. P removal efficiency of the larger prototype filter during the season of 2022-2023 with the flow rate below 4.8 m³/day.

*water flow was measured every week and this range represented the water flow on the measuring days.

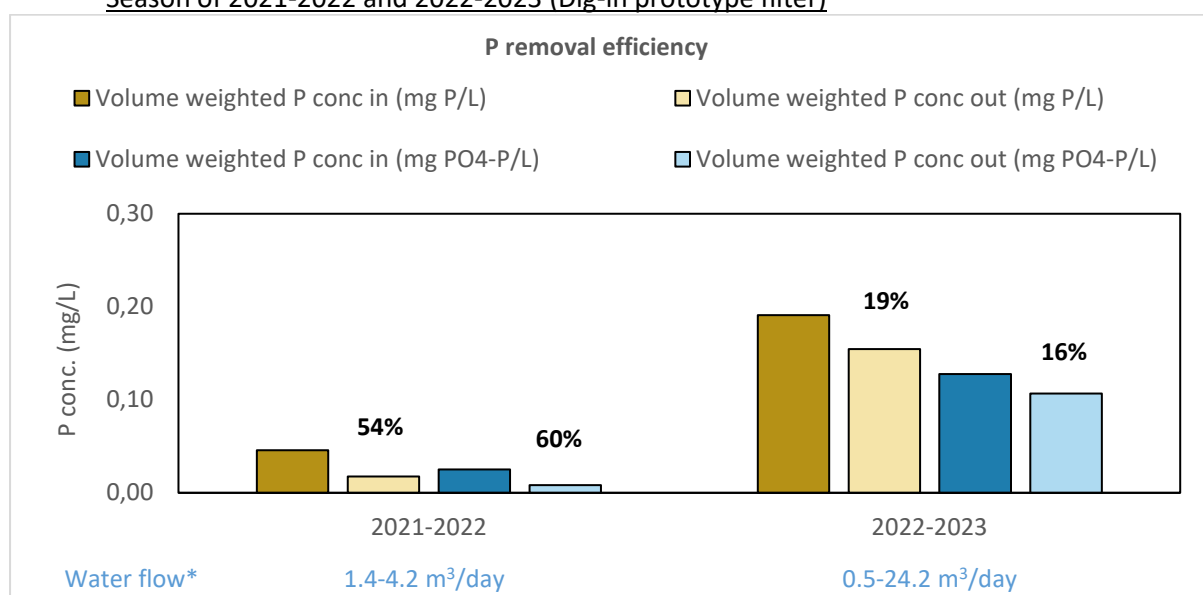
Figure 12. P removal efficiency of Dig-in_Staden_1 during the two seasons.

*water flow was measured every week and this range represented the water flow on the measuring days.

For the dig in filters, the drainage water showed low P concentration in the first drainage season. During the second drainage season, Dig-in_Staden_1 showed P removal efficiency of 55 % for TP and 53 % for DRP when flow rate lower than 4.8 m³/day. At the site of Dig-in_Staden_2, DRP remain lower than 0.1 ppm during the drainage season 2022-2023, while Dig-in_Staden_2 reduced TP by 62%.

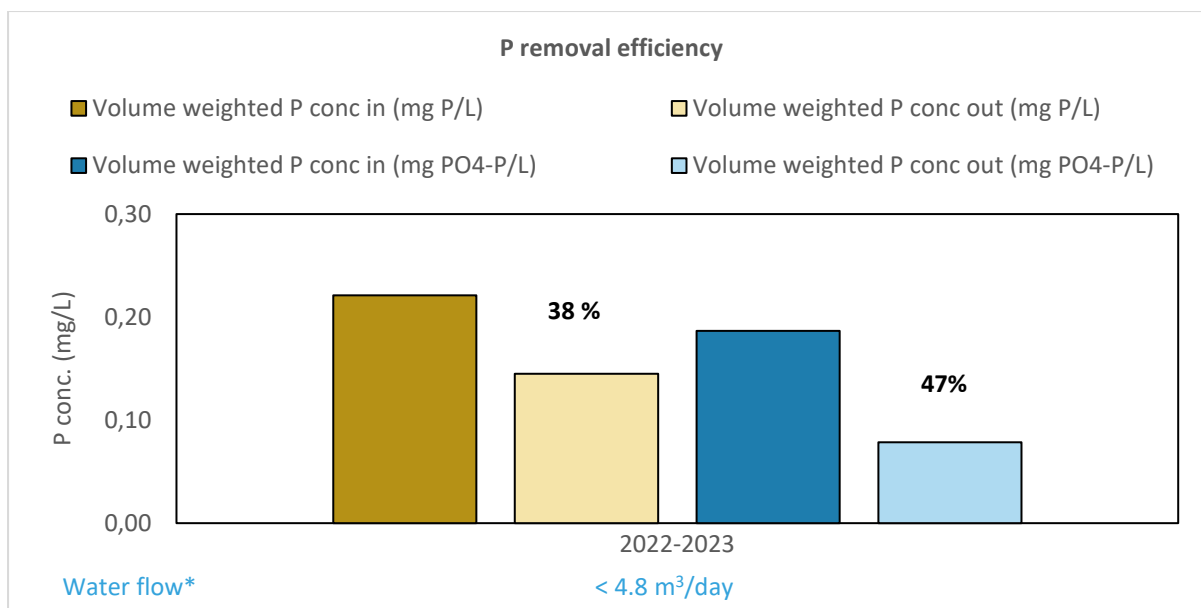
Figure 13. P removal efficiency of Dig-in_Staden_1 during season 2022-2023 with flow rates below 4.8m³/d.

*water flow was measured every week and this range represented the water flow on the measuring days.
