# Working with an outdoor pig unit to reduce soil & water pollution

## Wayland Farms, West Acre, Norfolk

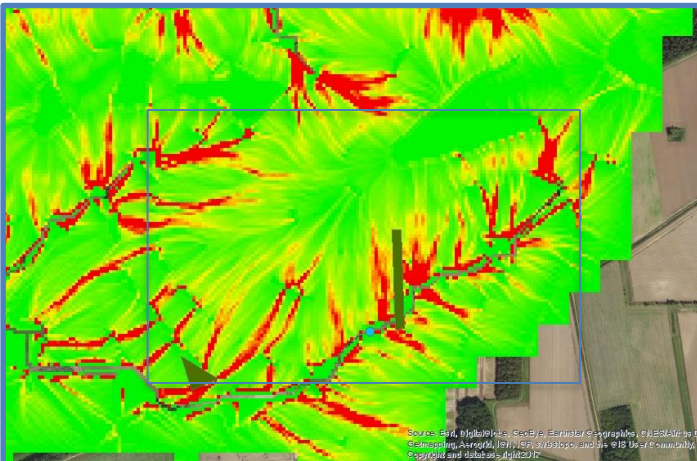
Figure 2. Diffuse pollution risk mapping (SCIMAP: red = high risk and green = low risk) of Wayland Farms (blue box).

An assessment of the site - using mapping (Figure 2), visual observations during a walkover and farmer knowledge - was conducted to identify locations where runoff was likely to occur. The analysis takes into account land use, soil type, rainfall and connectivity through pathways to the receptor.

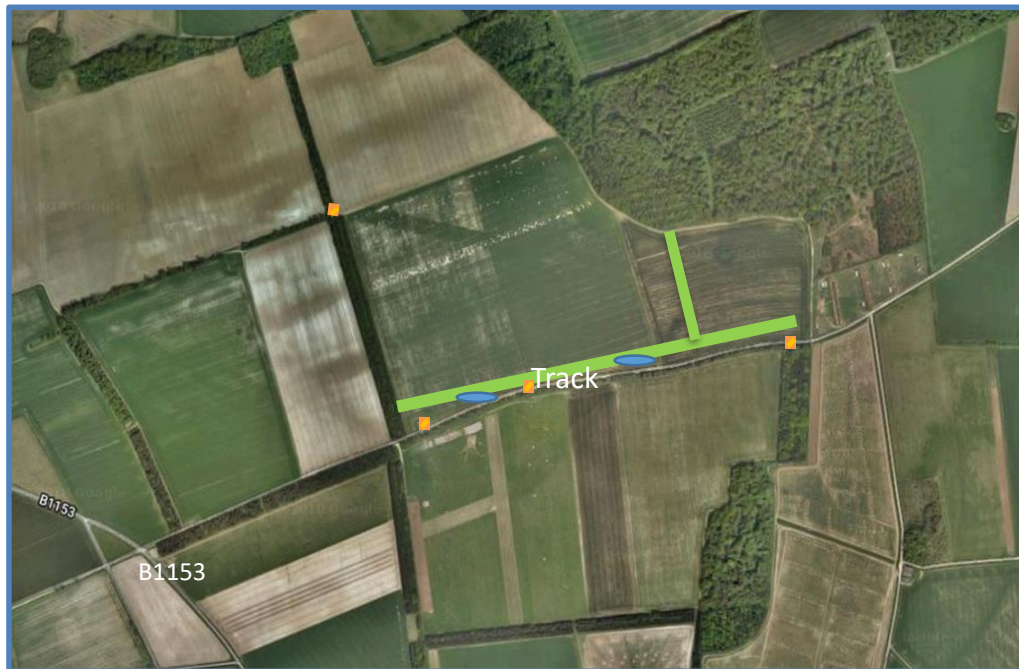
Since the field has a gentle slope, the run-off flows down to the farm track, which leads onto the B1153 road, where it could eventually reach the watercourse (Figure 3).

Figure 3. Locations for silt traps, buffer strips and track humps.

It was decided that two silt traps would be installed at the site (Figures 3, 4 & 5) with grant funding through the Water Sensitive Farming initiative. The traps work by capturing and slowing down polluted run-off, which enables the sediment and suspended solids to settle out. This is important as the solids can have pollutants such as nitrates and phosphates attached to them.

A couple of buffer strips were also implemented to reduce run-off and provide an extra habitat. In addition, track restoration work also took place to trap run-off e.g. hump and cross-drain construction (Figure 3). The accumulated sediments are then returned to the field where it will benefit the farm.

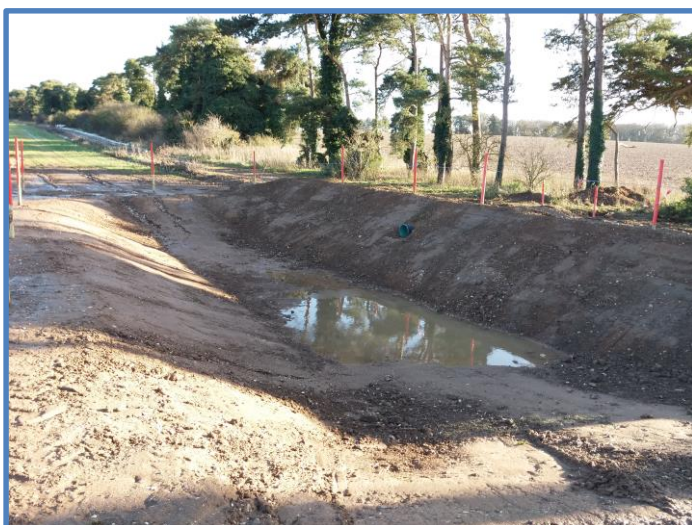
Figure 4. Silt trap (1) installed in December 2017.

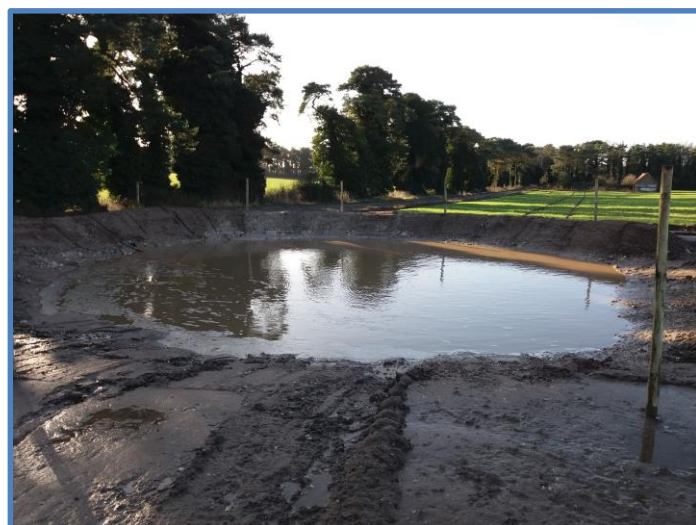
Figure 5. Silt trap (2) installed in December 2017, complete and capturing run off.
